FINDING MH370

OBJECT DISCOVERED: COULD BE MISSING MALAYSIA AIRLINES AIRCRAFT FLIGHT MH370

SITE VISIT TO OBJECT LOCATION in the MALDIVES (5-14th Dec 2015)

WORK IN PROGRESS BRIEF – FWS (17th January 2016)

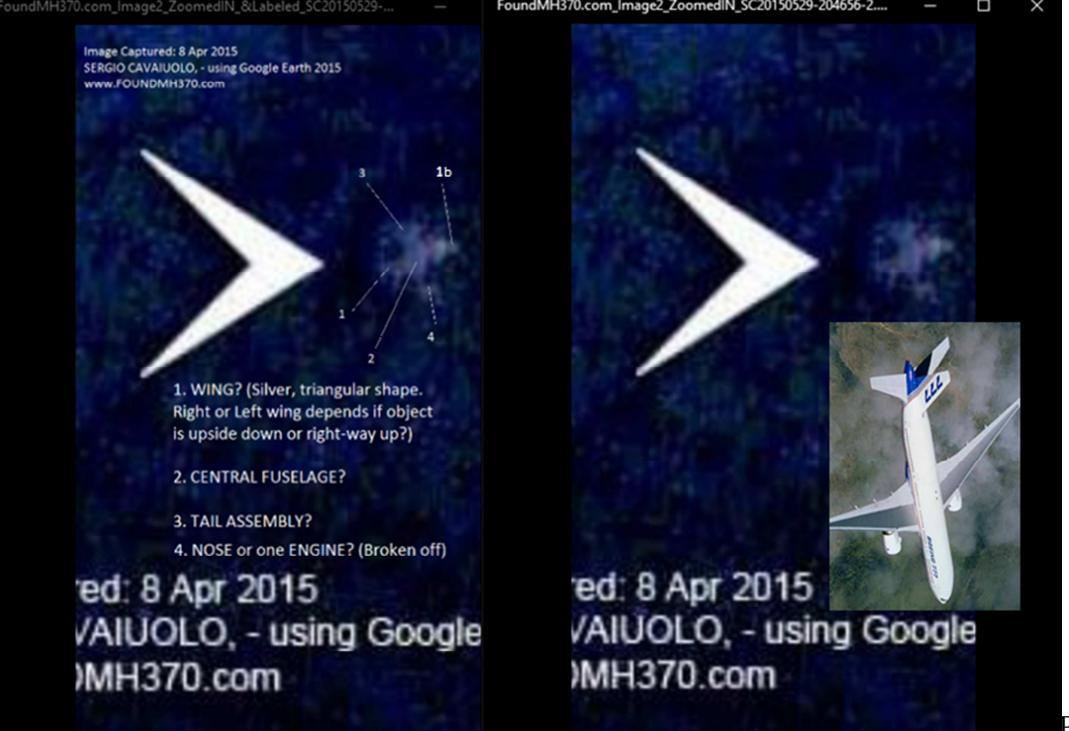
Image 2b - Extract from <u>www.FoundMH370.com</u>

Continuing my private research to help the global search for the missing Malaysia Airlines Flight #MH370, I travelled to the Maldives between the 5th and 14th December 2015, and visited the remote Indian Ocean location where my past research identified what appears to be a large "Aircraft-shaped" object resting in Maldives waters. My research is indicating this object could be the missing #MH370 main fuselage. See 'Image 2b' below identifying the "Aircraft-like" features on the object. Note the Tail Assembly [3] appears to be possibly broken off but laying near and at the rear of the main fuselage [2], the nose [4] also appears broken off, and the left wing [1b] looks possibly inverted (with respect to the rest of the object) such that the engine is visible - or some other large white component laying across it. The Boeing 777 plane inset has been added to show the apparent orientation of the object.

The following pages contain the analysis of several of the sonar images collected. With reference to the "Aircraft-Shaped" object orientation (Refer Image 2b above), I defined several search pattern grids over and around the object location and then proceeded to execute each pattern. As we traversed each segments of this search pattern with the boat the Fish Finder was used to capture sonar imagery of the sea floor as we traversed along. At the same time, video recordings of the Fish Finder sonar display were taken in 'real time' for later analysis . The figure below shows some of the scan segments executed over the top of the object at the location. (I have not included all the search patterns in this status brief *still work to go*)

Captured during conduct of search pattern segment from TR1 to NL1. This is a pass from the right-of-tail (TR1) to left-of-the-nose (See line TR1 to NL1 on Image 2b). This scan segment passes across a part of the right wing, over the fuselage and towards the vacant area left of the nose. The large circular bump in the Sonar image (ie. the light blue area) shows a strong solid sonar return with a very smooth profile. The height of the circular bump (in the Left Sonar image) is about 10m high. As a comparison, the top of the fuselage of a Boeing 777-200ER is about 9m high from ground level. (This is just a relative comparison for the height of the bump). This circular bump could be the central fuselage given that this scan segment (TR1 to NL1) passes over the top of the centre of the object. The yellow outline shown on the Scale Model Replica identifies a possible aircraft surface that could have produced the resultant sonar returns seen on the Fish Finder display screen captures below.

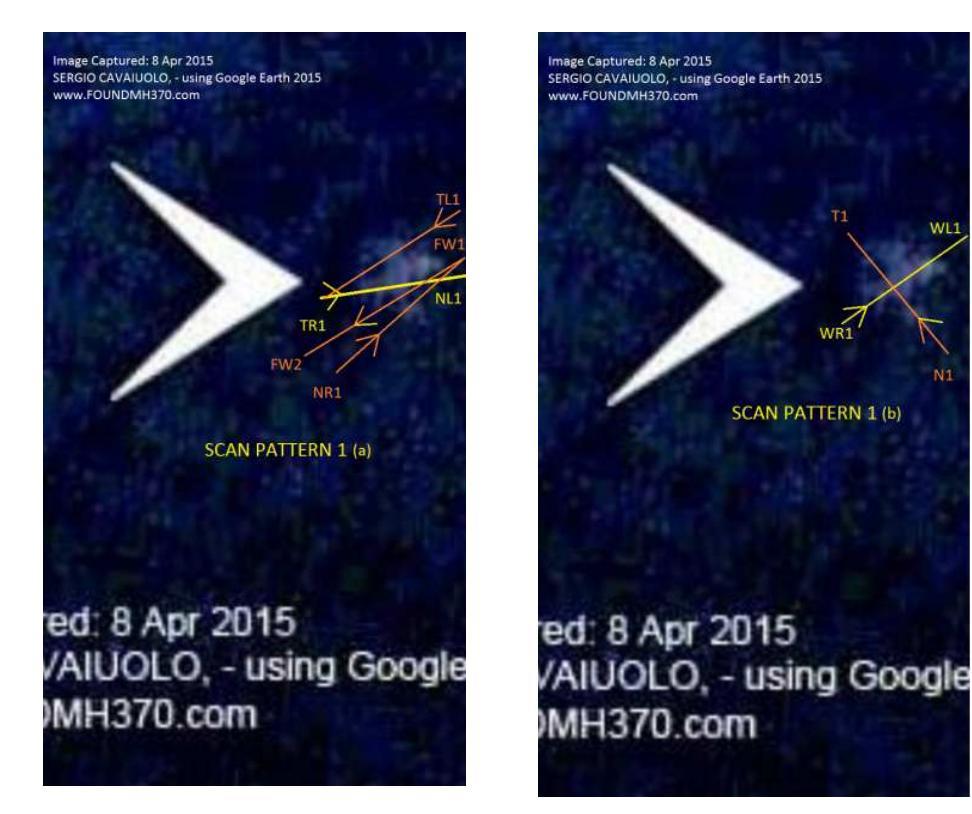
The Search Pattern way point references are defined as follows and are with respect to an aircraft object:-

N1: Nose; T1: Tail
NL1: Left of Nose; NR1: Right of Nose
FW1: Forward of Left Wing;
FW2: Forward of Right Wing;
WL1: Left Wing; WR1: Right Wing
TL: Left of Tail; TR: Right of Tail

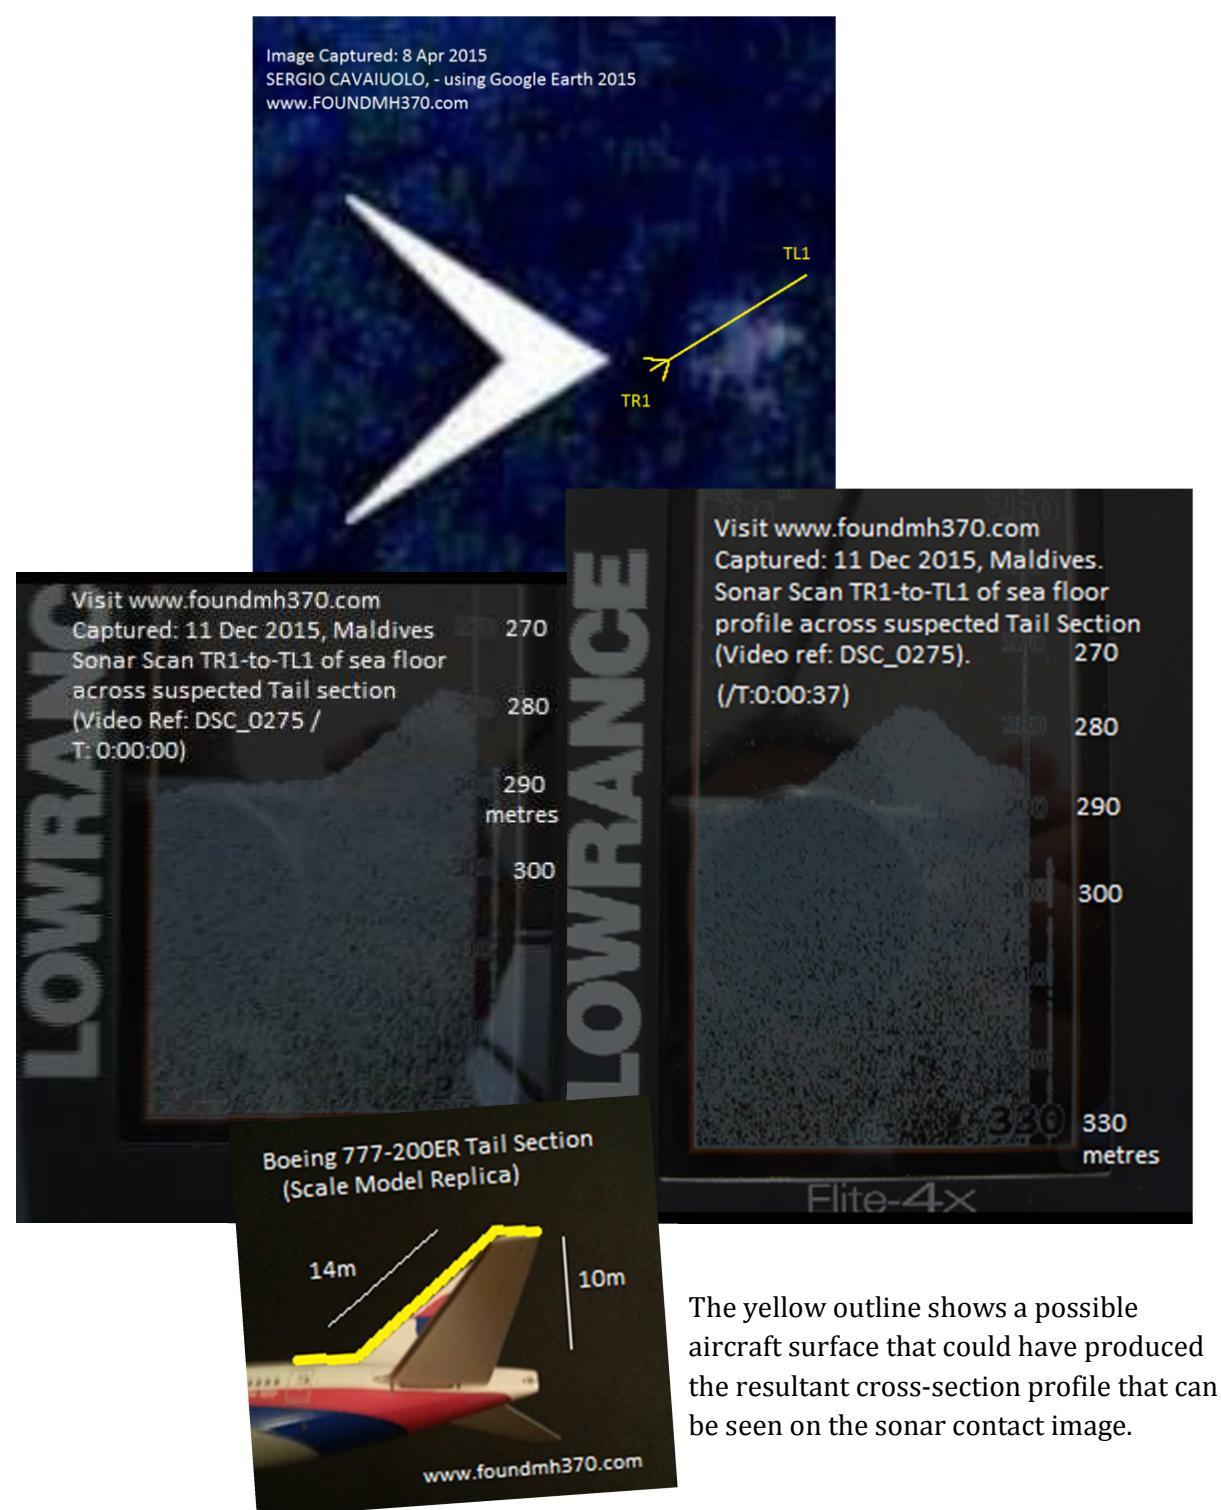
SONAR SCAN ACROSS OBJECT TAIL SECTION (SCAN TR1 TO TL1) Screen capture from sonar scan, video Ref: DSC_0275 /at t = 0:00:37.

Captured during conduct of search pattern segment from TR1 to TL1 whilst passing across what is labelled as the Tail Assembly (See line TR1 to TL1 on Image 2b). The bump in the Sonar image appears to have distinct straight edges and corners that appear similar to features of an aircraft Tail Section – in terms of shape, angle and approximate dimensions.
